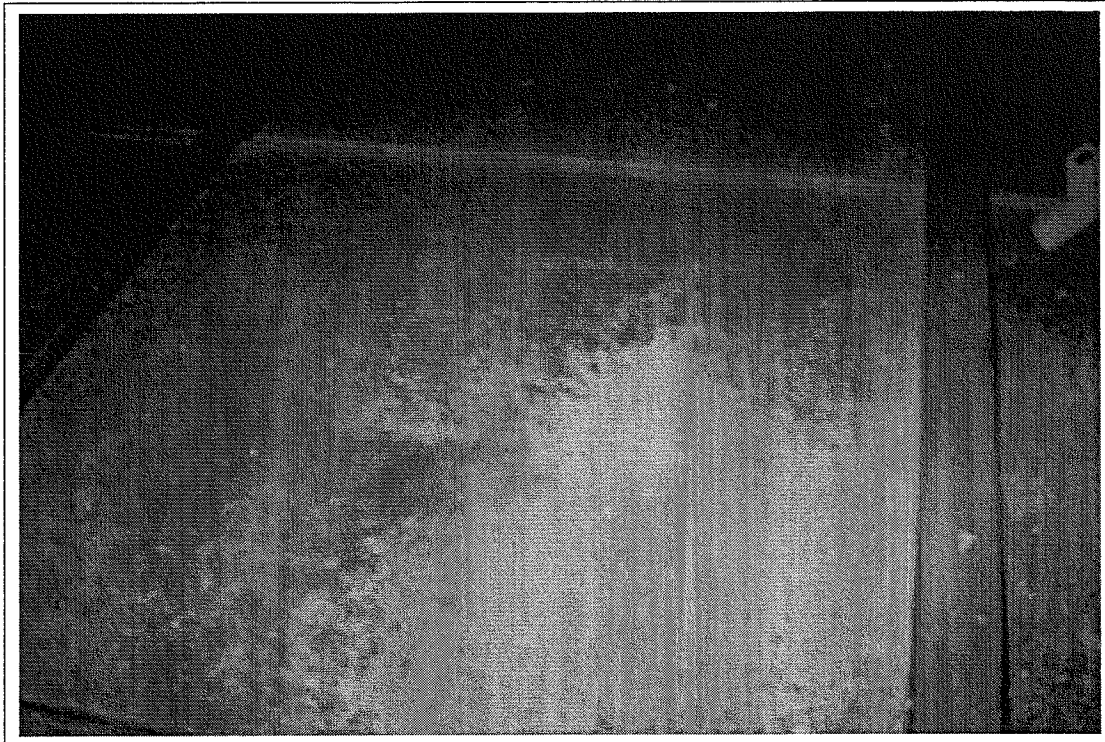
Photo 147. Location of Dust Sample # 2 (top of 1' x1' ceiling tile), above concealed spline ceiling system beneath fireproofing, East wing, 2nd floor Room L 211

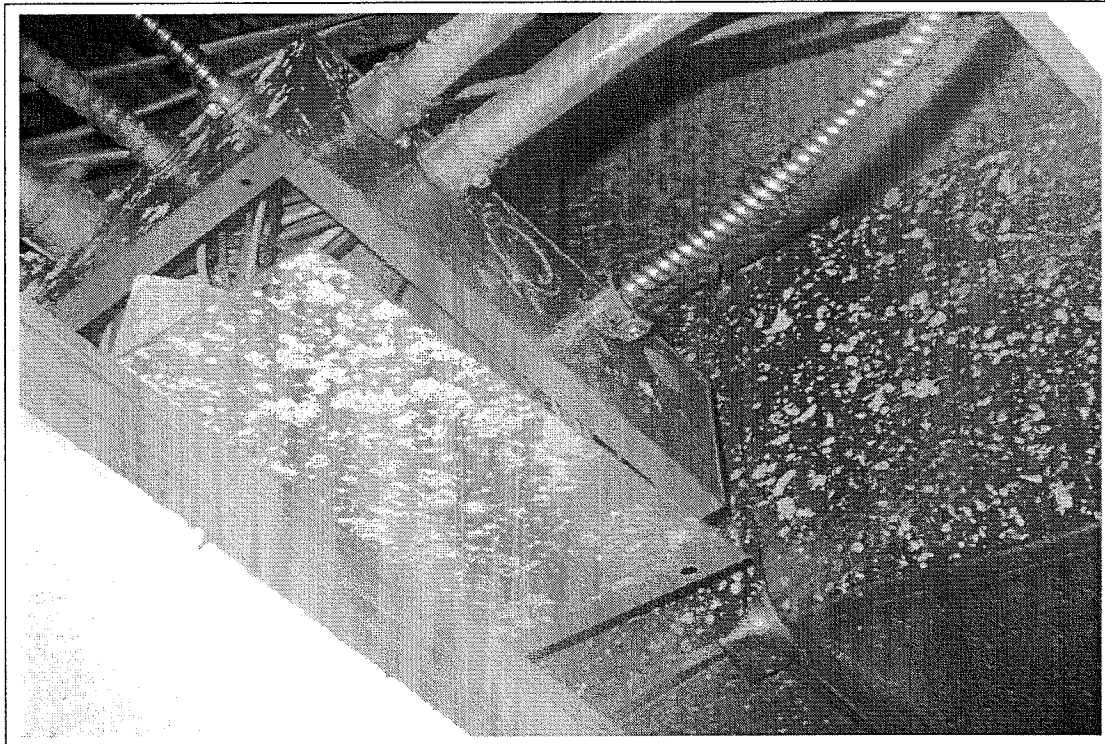
Photo 148. View of fireproofing overspray on underside of electrical junction box in plenum space above ceiling in East wing, 1st floor microfiche room L112

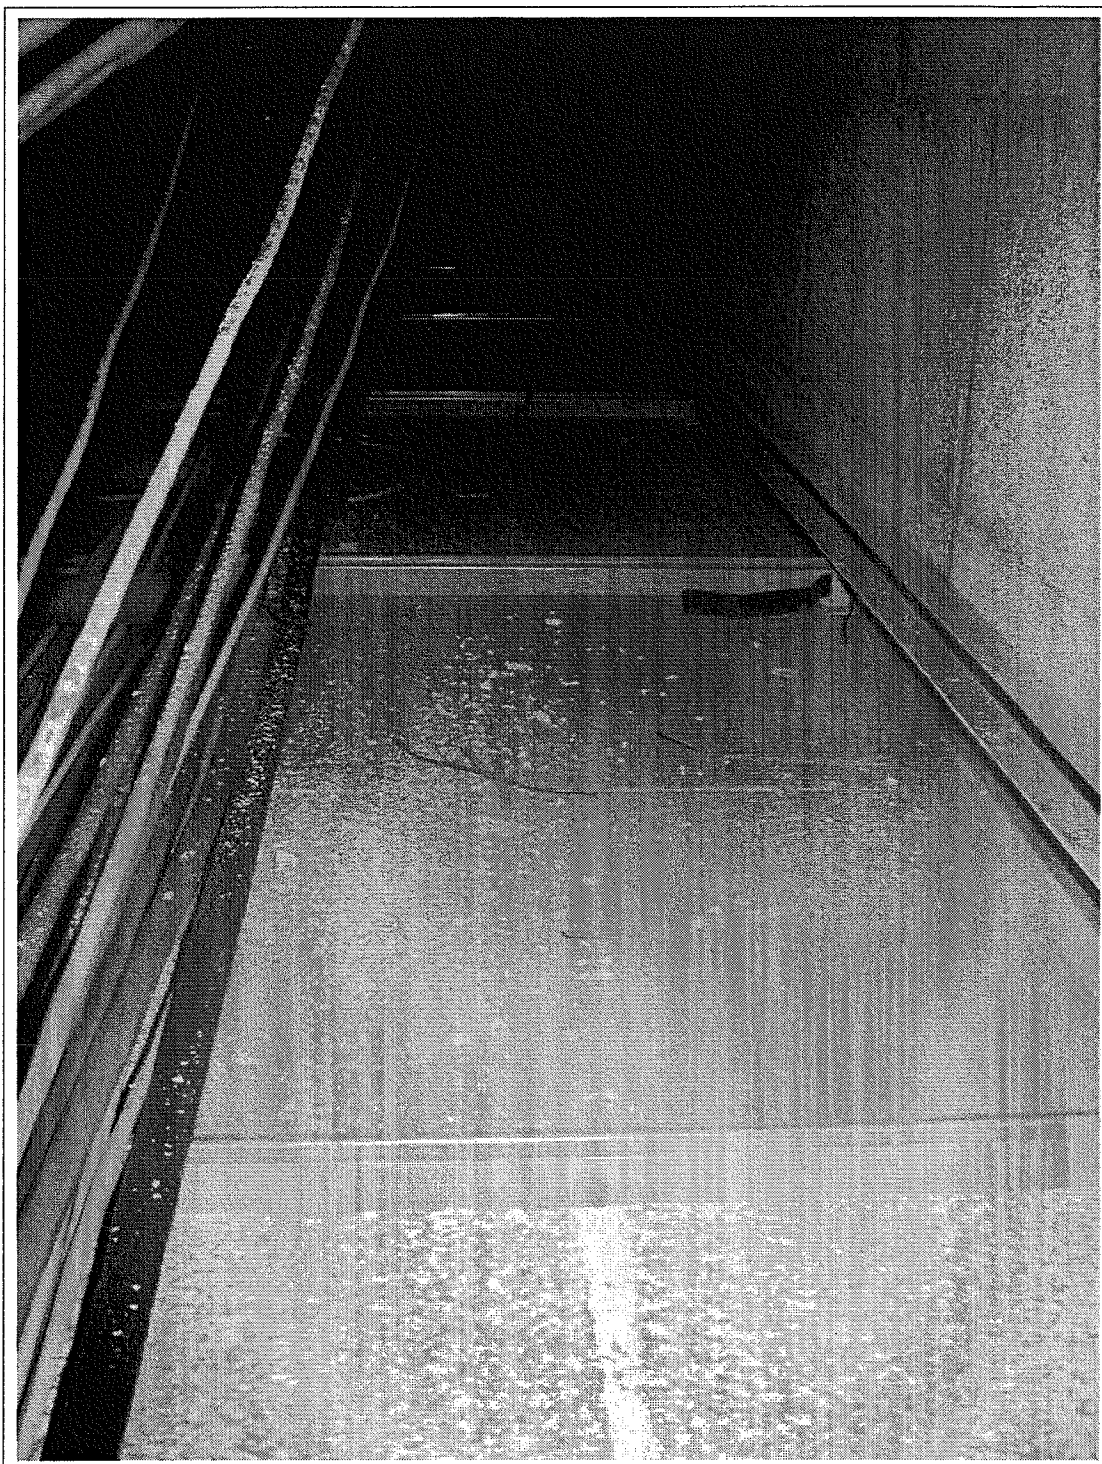
Photo 149. View of dislodged fireproofing debris on top of suspended ceiling tiles and pulled cables in East wing, 1st floor Public Corridor 3#

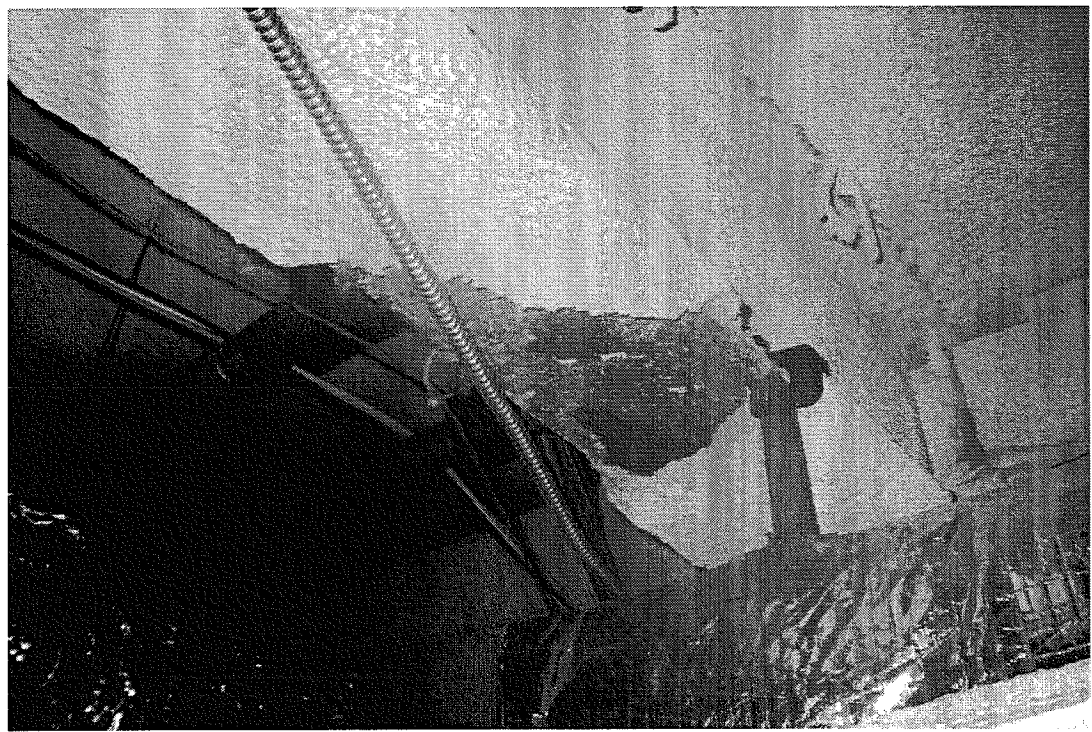
Photo 150. View of dislodged fireproofing missing from bottom of I-beam flange above suspended ceiling in East wing, 1st floor Room L103

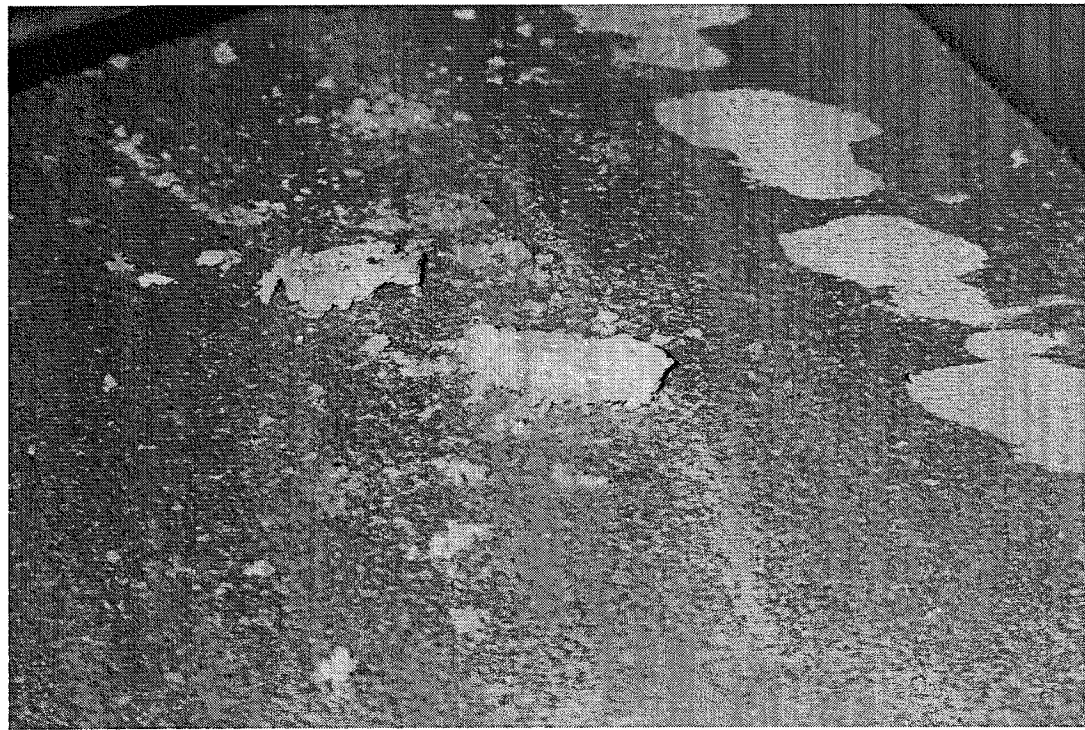
Photo 151. Close-up of dislodged fireproofing on top of suspended ceiling in East wing, 1st floor Room L103

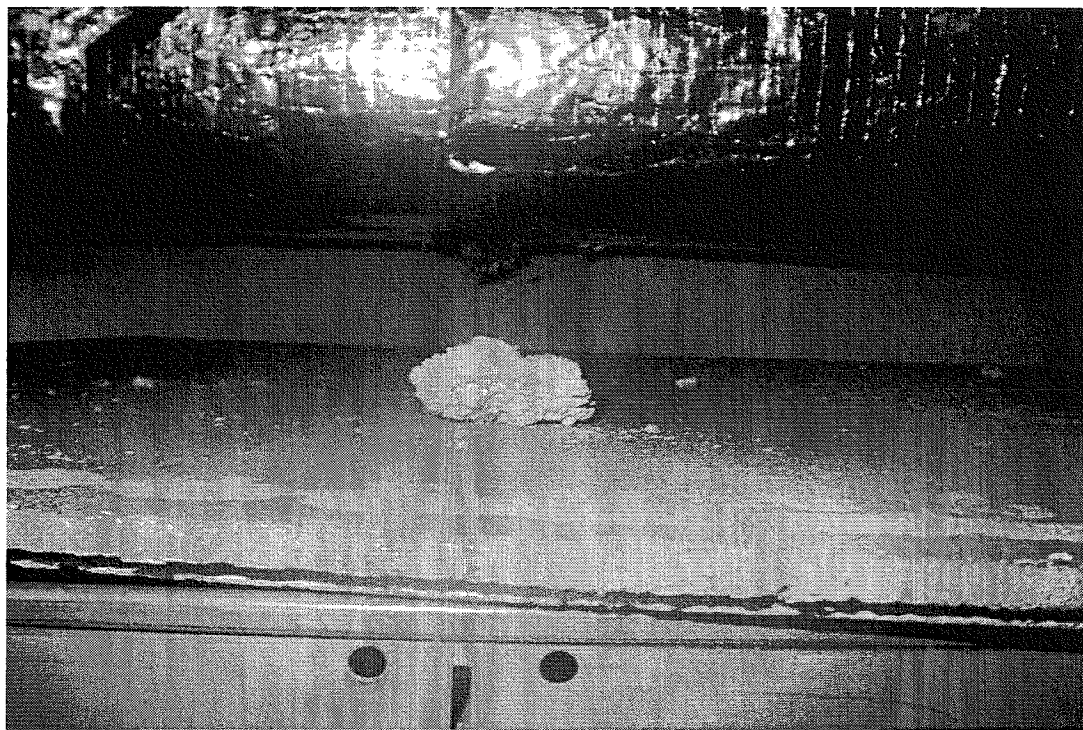
Photo 152. Close-up of dislodged fireproofing chunk on top of "moved" ceiling tile to provide access to plenum in East wing, 1st floor Room L103

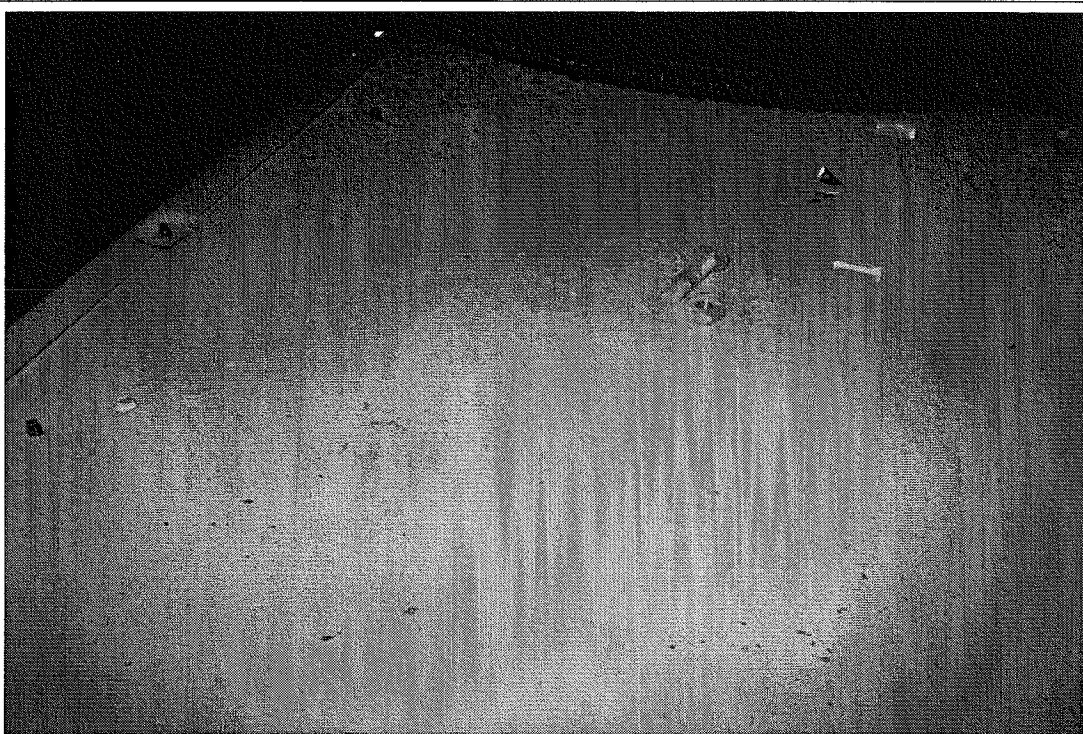
Photo 153. Location of Dust Sample # 3 and Surface Contact Sample # A (top of fluorescent light fixture), above suspended ceiling in East wing, 1st floor Room L103
